# BROWNERE, LLC - RETRACEMENT SURVEY

LOTS 14 & 15 IN "BITTERSWEET LAKE" IN SECTION 10, TOWNSHIP 10 NORTH, RANGE 3 EAST

# SURVEYOR'S REPORT

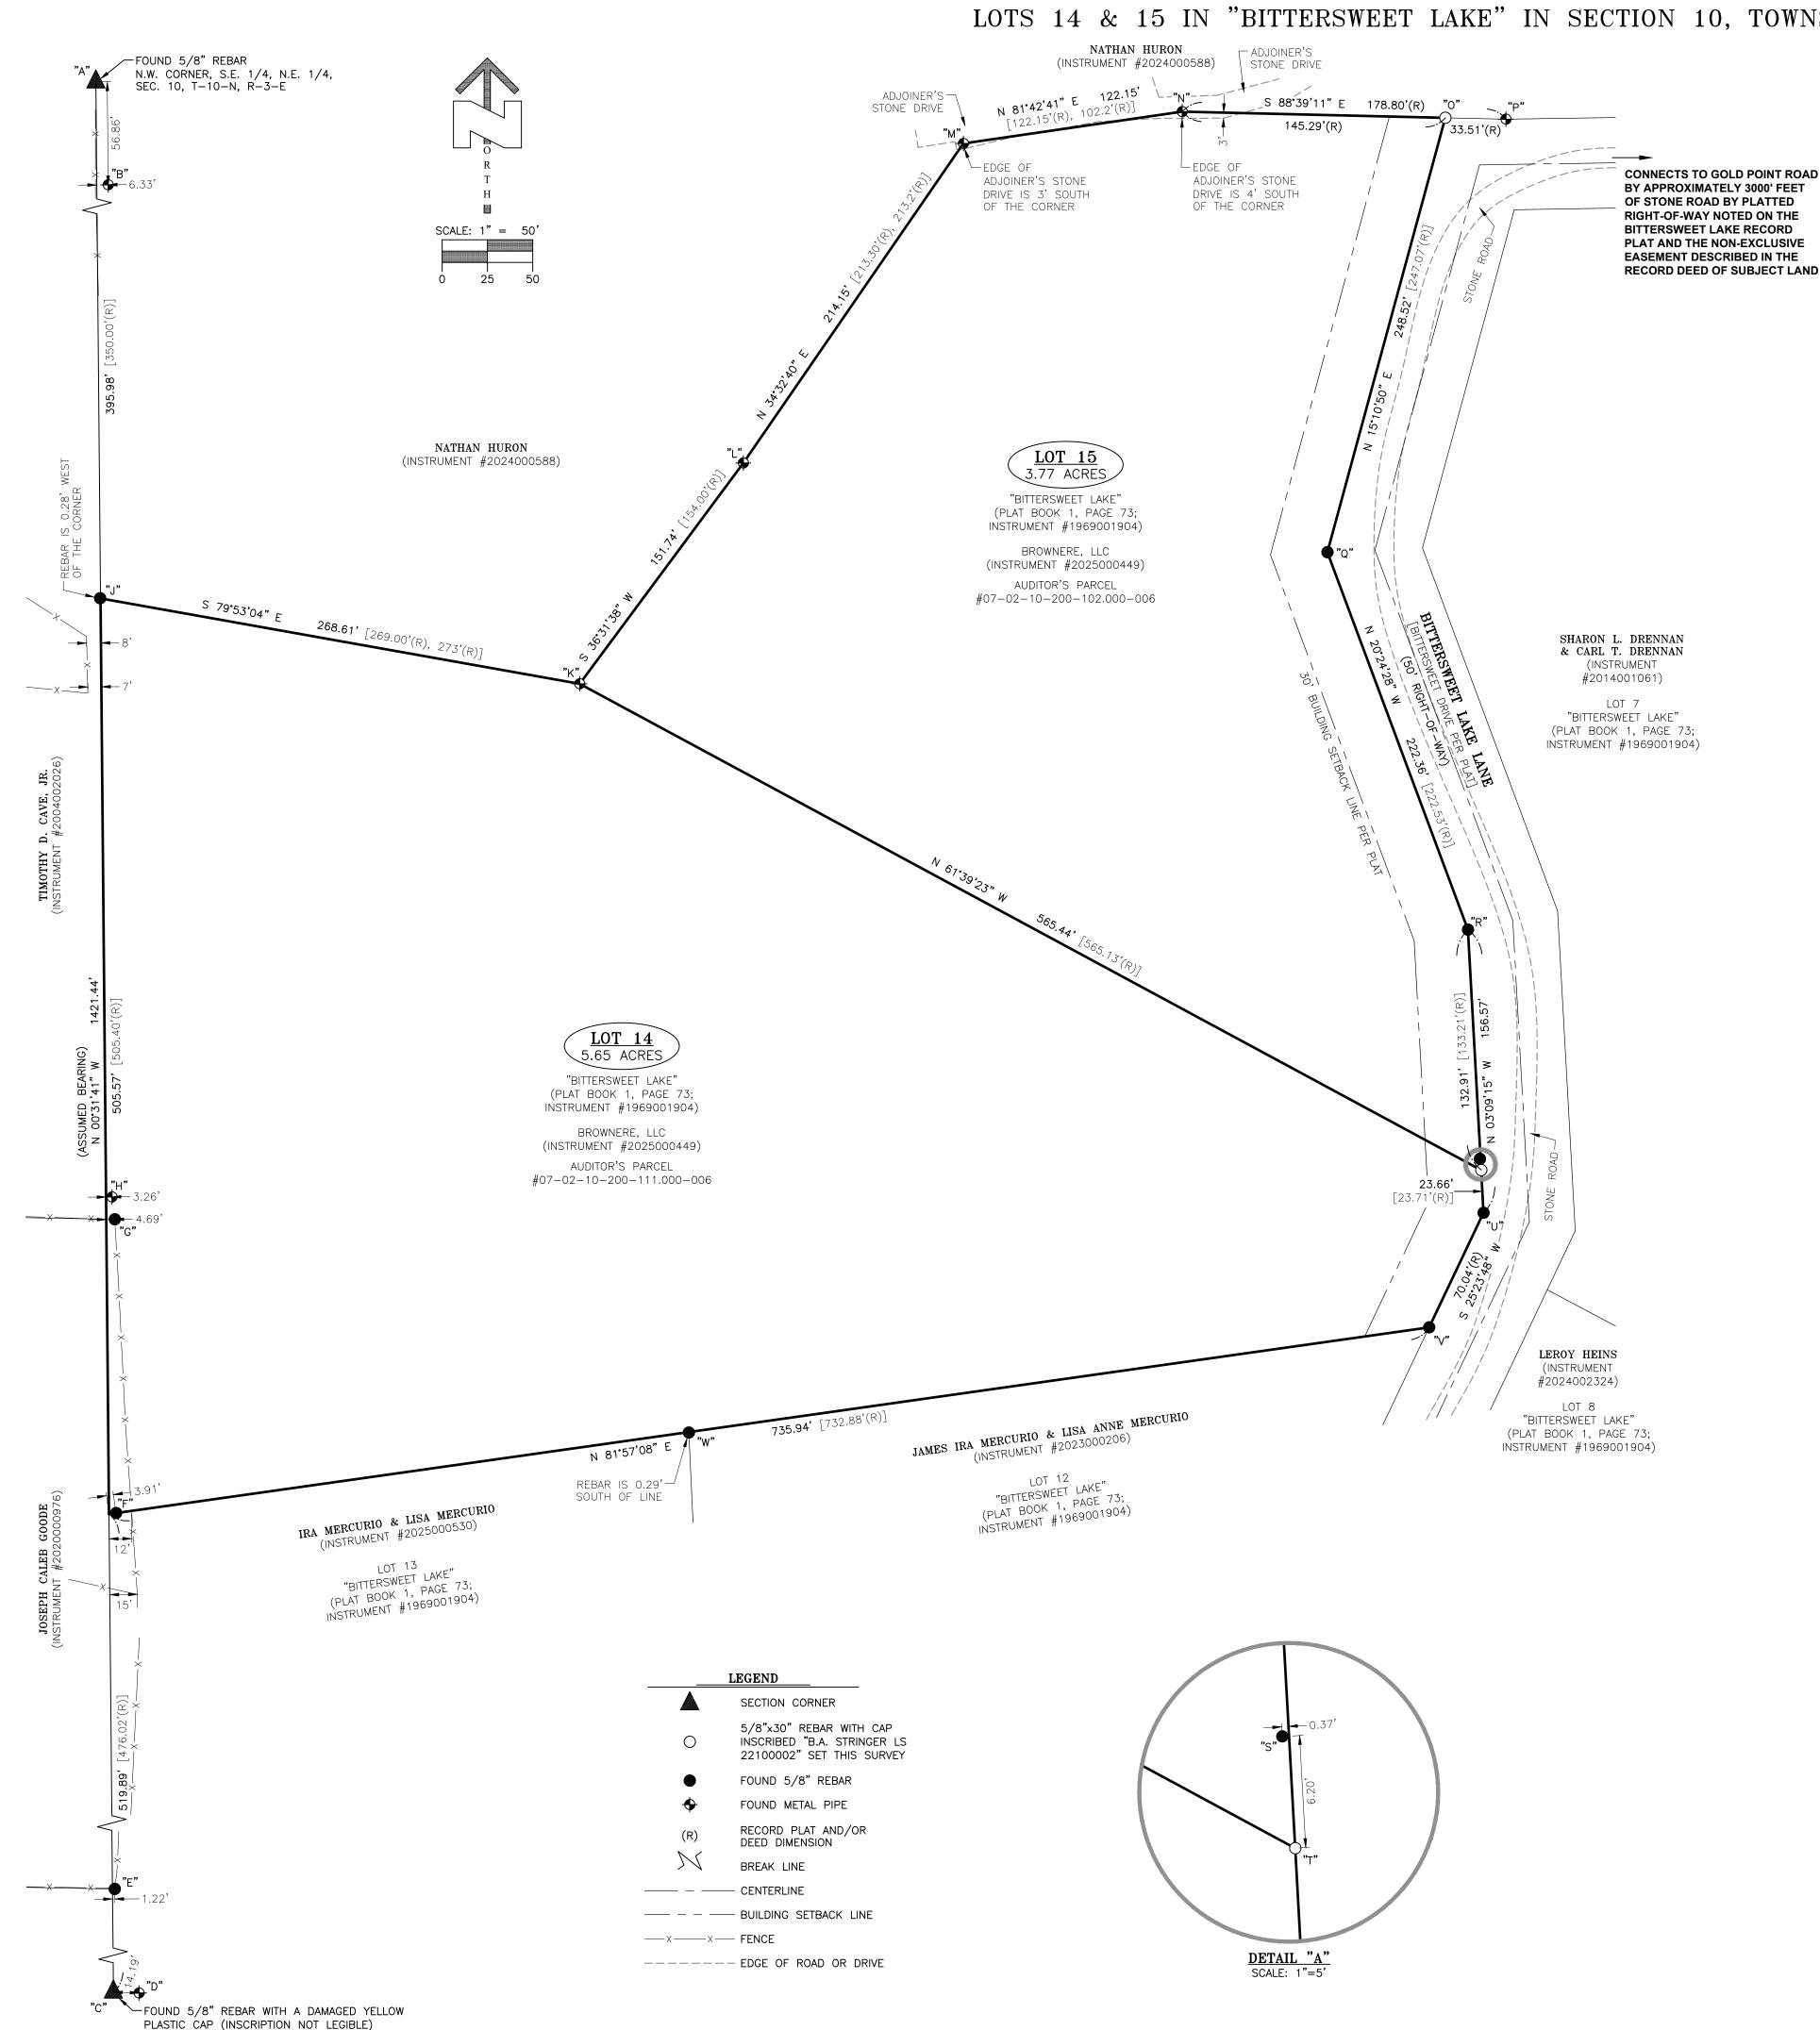
S.W. CORNER, S.E. 1/4, N.E. 1/4,

SEC. 10, T-10-N, R-3-E

FINDINGS OF FACTS:
"A" - A 5/8" REBAR WAS FOUND MARKING THE NORTHWEST CORNER OF THE SOUTHEAST QUARTER OF THE NORTHEAST QUARTER OF SECTION 10. ORIGIN: UNKNOWN. THE REBAR IS ON RECORD IN THE BROWN COUNTY SURVEYOR'S OFFICE AS MARKING THE CORNER. THE COUNTY SURVEYOR'S TIES TO THE REBAR WERE USED TO VERIFY THE LOCATION OF THE REBAR AND THAT IT IS THE SAME REBAR NOTED BY THE COUNTY SURVEYOR AS MARKING THE CORNER. I WILL NOTE THAT THERE IS A 45.98'-90.02' UNCERTAINTY IN THE FIELD MEASURED LOCATION OF THE REBAR, AS COMPARED TO MONUMENTS "C" AND "J" AND THE GEOMETRICS OF THE RECORD PLAT. ALSO, I WILL NOTE THAT THE FIELD MEASURED DISTANCED BETWEEN MONUMENTS "A" AND "C" IS 101.44' LONGER THAN THE THEORETICAL QUARTER MILE DISTANCE OF 1320'. THE REBAR IS IN GOOD CONDITION AND THE TOP OF THE REBAR IS 2" BELOW THE SURFACE OF THE GROUND.

"B" - A 1" METAL PIPE WAS FOUND 6.33' EAST OF LINE "A"-"C" AND 56.86' SOUTH OF MONUMENT "A". ORIGIN: UNKNOWN. THE PIPE IS NOT IN POOR CONDITION AS IT IS LEANING, LOOSE IN THE GROUND, AND THE TOP OF THE PIPE IS 30" ABOVE THE SURFACE OF THE GROUND.

"C" - A 5/8" REBAR WITH A DAMAGED YELLOW PLASTIC CAP (INSCRIPTION NOT LEGIBLE) WAS FOUND MARKING THE SOUTHWEST CORNER OF THE SOUTHEAST QUARTER OF THE NORTHEAST QUARTER OF SECTION 10. ORIGIN: THE REBAR APPEARS TO BE THE "5/8" REBAR W/CAP SET" THAT WAS SET BY JAMES C. BENNETT IN REFERENCE SURVEY #2. I WILL NOTE THAT THE REBAR IS NOT NOTED ON SAID SURVEY AS MARKING SAID QUARTER-QUARTER CORNER. HOWEVER, THE REBAR IS ON RECORD IN THE COUNTY SURVEYOR'S OFFICE AS MARKING THE CORNER AND WAS ALSO HELD AS MARKING THE CORNER IN REFERENCE SURVEY #3. FURTHERMORE, I WILL NOTE THAT THERE IS A 43.87'-90.02' UNCERTAINTY IN THE FIELD MEASURED LOCATION OF THE REBAR AS COMPARED TO MONUMENTS "C" AND "E" AND THE GEOMETRICS OF THE RECORD PLAT. AGAIN, I WILL ALSO NOTE THAT THE FIELD MEASURED DISTANCED BETWEEN MONUMENTS "A" AND "C" IS 101.44' LONGER THAN THE THEORETICAL QUARTER MILE DISTANCE OF 1320'. DESPITE THE DAMAGED PLASTIC PLASTIC CAP, THE REBAR IS IN GOOD CONDITION AND THE TOP OF THE CAP ON THE REBAR IS 4" ABOVE THE SURFACE OF THE GROUND.

"D" - A 3/4" METAL PINCH PIPE WAS FOUND 14.19' EAST OF "C". ORIGIN: UNKNOWN. A REBAR WAS FOUND EAST OF "C" IN REFERENCE SURVEY #2 DEPICTED AS BEING IN THE GENERAL VICINITY OF THE FOUND PIPE. THE PIPE IS IN GOOD CONDITION AND THE TOP OF THE PIPE IS 2" ABOVE THE SURFACE OF THE

"E" - A 5/8" REBAR WITH CAP (BENNETT) WAS FOUND 1.22' EAST OF LINE "A"-"C" AND IN THE VICINITY OF THE SOUTHEAST CORNER OF THE LAND OF "GOODE" (INSTRUMENT #2020000976). ORIGIN: THE REBAR WAS SET IN REFERENCE SURVEY #2. THE REBAR IS IN GOOD CONDITION AND THE TOP OF THE REBAR IS 4" ABOVE THE SURFACE OF THE GROUND.

"F" — A BENT 5/8" REBAR WAS FOUND 3.91' EAST OF LINE "A"—"C", AS MEASURED ALONG LINE "F"—"V", AND IN THE VICINITY OF THE SOUTHWEST CORNER OF LOT 14. ORIGIN: THE REBAR MAY BE THE "IRON PIN IN PLACE" NOTED AS MARKING THE CORNER ON REFERENCE SURVEY #1. ALTHOUGH BENT, THE REBAR IS IN FAIR CONDITION AS IT IS STABLE IN THE GROUND AND THE TOP OF THE REBAR IS EVEN WITH THE SURFACE

"G" - A 5/8" REBAR WITH A PLASTIC CAP (INSCRIPTION NOT LEGIBLE) WAS FOUND 4.69' EAST OF LINE "A"-"C" AND IN THE VICINITY OF THE NORTHEAST CORNER OF THE LAND OF "GOODE" (INSTRUMENT #2020000976). ORIGIN: THE REBAR APPEARS TO BE THE "5/8" REBAR W/CAP SET" THAT WAS SET BY JAMES C. BENNETT IN REFERENCE SURVEY #2. DESPITE THE DAMAGED PLASTIC PLASTIC CAP, THE REBAR IS IN GOOD CONDITION, IS LOCATED AT THE CORNER OF A WOVEN WIRE FENCE, AND THE TOP OF THE CAP ON THE REBAR IS 1" ABOVE THE SURFACE OF THE GROUND.

"O" - A SEARCH WAS MADE IN THE VICINITY OF THE NORTHEAST CORNER OF LOT 15. NO MONUMENT WAS FOUND MARKING THE CORNER. AN "IRON PIN IN PLACE" IS NOTED AS MARKING THE CORNER ON REFERENCE
